**CALIFORNIA DEPARTMENT OF CONSERVATION
DIVISION OF MINES AND GEOLOGY**

**FAULT EVALUATION REPORT FER-239
SURFACE FAULT RUPTURE ALONG THE
HOMESTEAD VALLEY, EMERSON,
AND RELATED FAULTS ASSOCIATED WITH THE
M_w 7.3 28 JUNE 1992 LANDERS EARTHQUAKE**

by
William A. Bryant
Associate Geologist
July 18, 1994

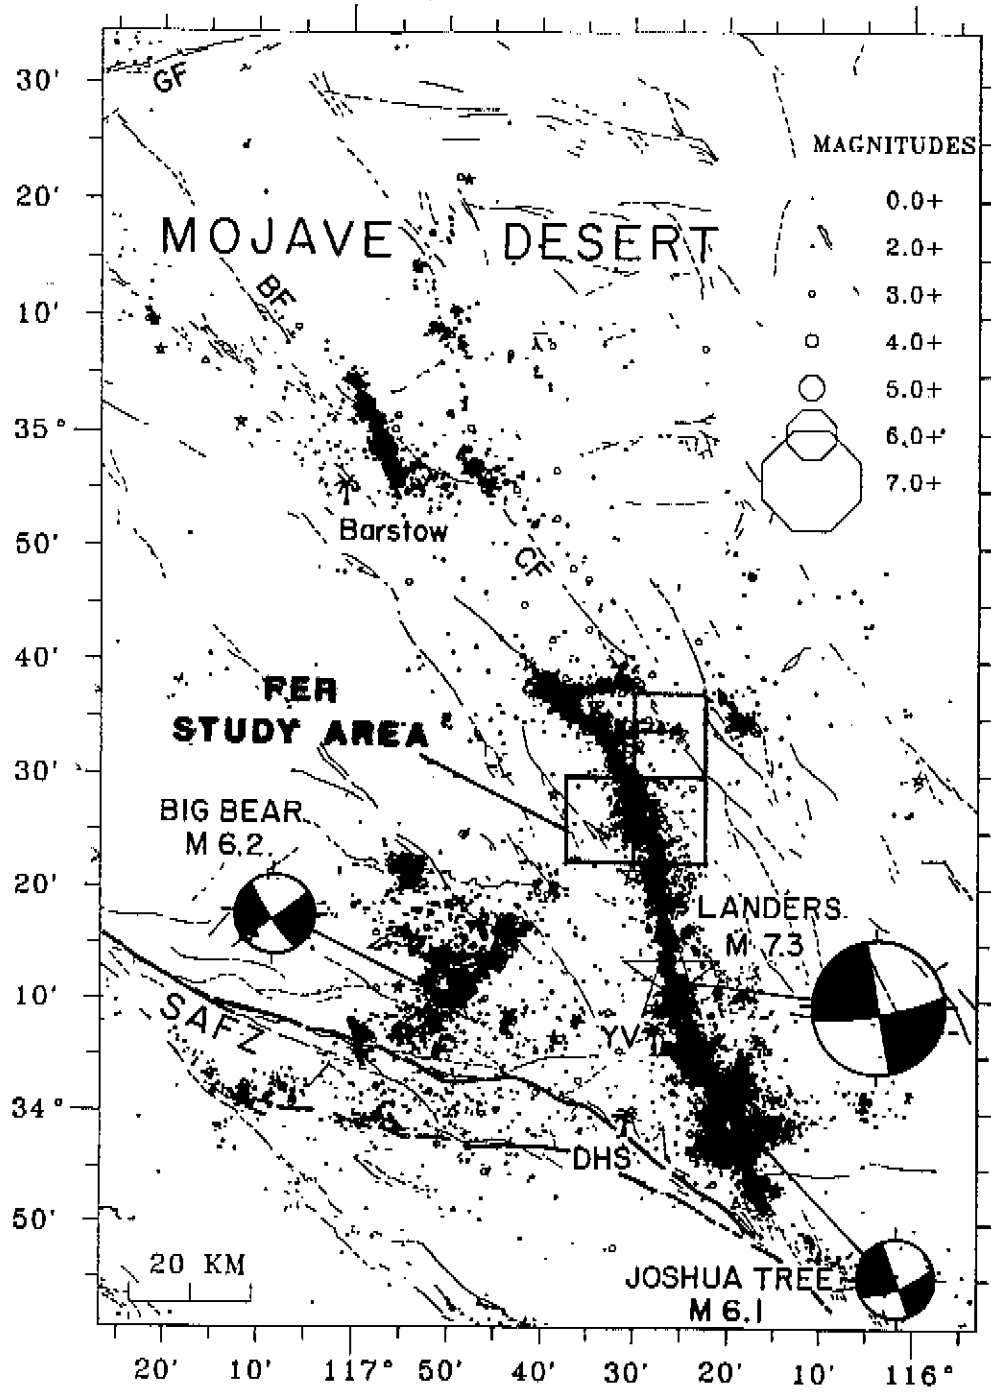
Rupture extended for approximately 85 km along a north to northwest trend from south of the town of Yucca Valley to about 32 km southeast of Barstow (Figure 5a). Fault rupture was characterized by predominantly right-lateral strike-slip displacement along previously mapped faults, although significant fault rupture occurred along several unmapped faults. Right-lateral strike-slip displacement averaged about 200 to 300 centimeters (cm) and reached a maximum of about 600 cm along the Emerson fault (located north of the Melville Lake-Emerson Lake study area). Vertical displacements often were associated with the strike-slip displacement and ranged from an average of 30 cm (both west and east sides down) to a maximum of about 200 cm (west side down) along the Emerson fault.

Figure 5a (to FER-239). Seismicity in the Melville Lake-Emerson Lake study area for the period April to December 1992. Lower hemisphere focal mechanisms (compressional quadrant shaded) of the three main earthquakes in the Landers area are shown. BF, Blackwater fault; CF, Calico fault; YV, Yucca Valley; GF, Garlock fault; SAFZ, San Andreas fault zone; DHS, Desert Hot Springs. *Modified from Hauksson and others, 1993.*

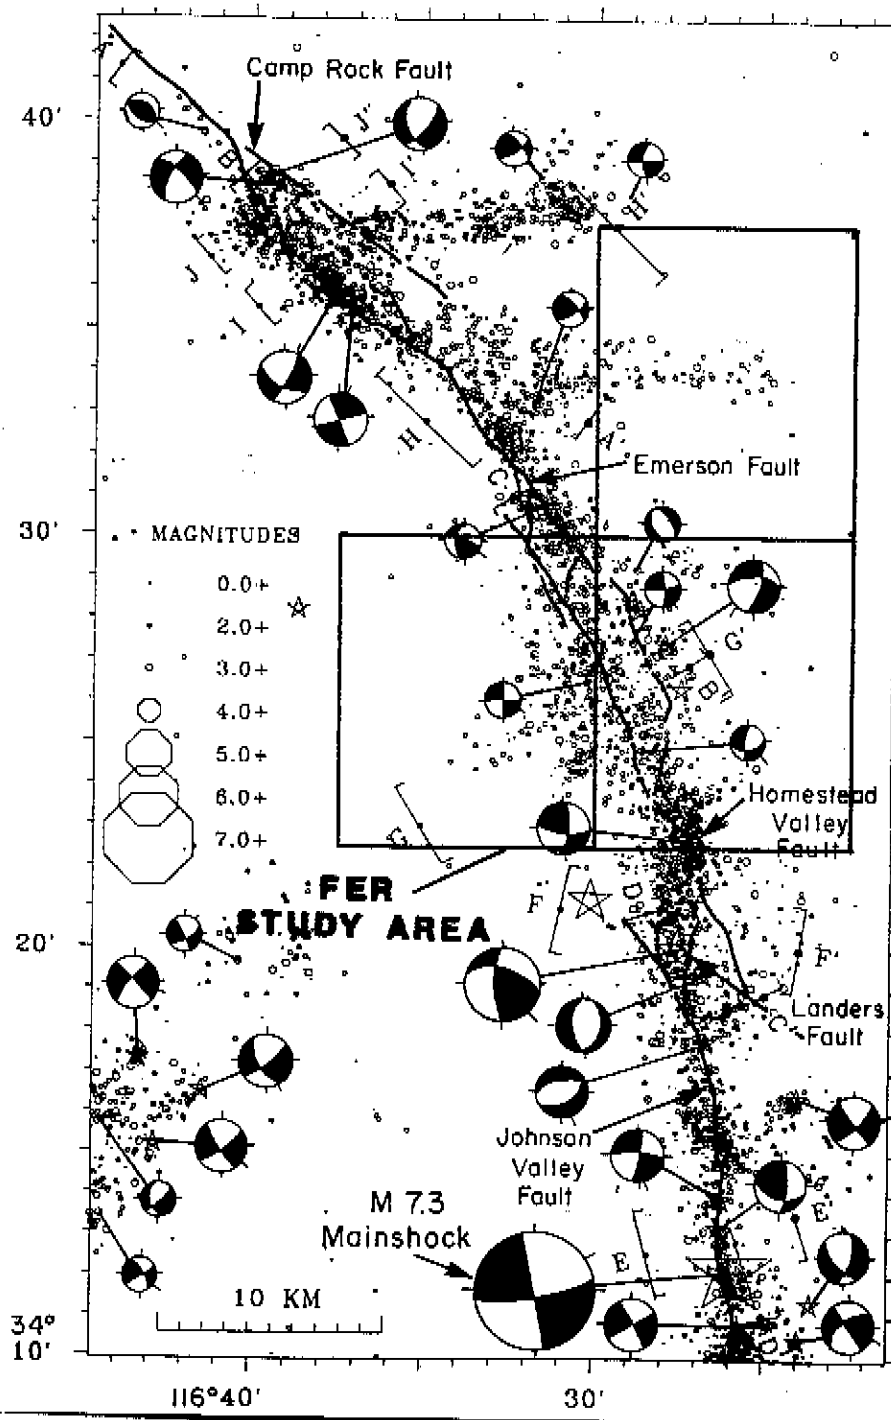
Earthquake epicenters in the FER study area for the period June to December 1992 are shown in Figure 5b (Hauksson and others, 1992). The Joshua Tree earthquake sequence of April 1992 is located south of the Pinto Mountain fault.

Figure 5b (to FER-239). Main shock and aftershocks of the 28 June 1992 Landers earthquake, 28 June to 31 December, 1992. Earthquakes $M \geq 4.0$ are shown by stars. Modified from Hauksson and others, 1993.
